**Flood Control Project Maintenance
Levee Inspections**
LMA District Cover Sheet
Spring 2019 Levee Inspection Results

Reclamation District No. 0787 Fair

Waterway			Bank	Unit Miles
Unit No. 01 Colusa Basin Drain			Left	4.45
	Spring (March - May)	Summer (June - August)	(September - November) Fall	Winter (December - February)
Unit Maintenance Rating (Fall Only)				
Date of Inspection	4/8/2019 - 4/8/2019			
DWR Inspector	Zach Jojola			
Accompanied By	Roger Cornwell River Garden Farms

Levee Inspection Report By Mile - Spring 2019

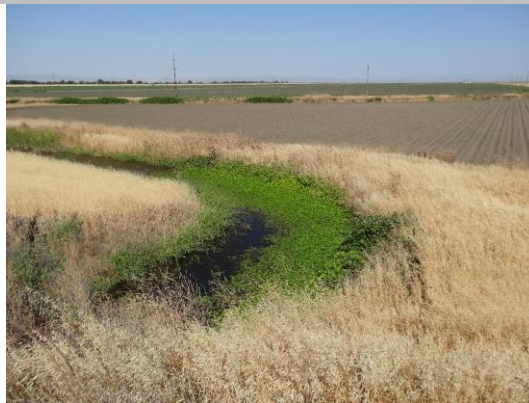
Photo 2 of 3 : UCIP_SP_2019_37585_68153.jpg

Comment Code					
Inspector Comment					
FS_ID:37585 DS_ID:22892 EP_NO: 9392 Repair Type: Non-Urgent Crossing Status: Found UCIP Comments: Dense vegetation limits the inspector's visibility to identify signs of pipe failure (leaks) along the slope. Recommend removing vegetation along pipe alignment to conduct proper inspection of structure. FIELD_STRUCT_DESC: 36-inch concrete irrigation pipe through the levee, 17 feet below the crown. Slide gate in 36-inch standpipe on the waterside (WS). 24-inch pipe from standpipe to pump house mounted on steel structure in channel. (36-inch pipe authorized under Automatic Board Order (ABO) issued as Permit No. 9392, 1974 - River Garden Farms; pump structure and 24-inch steel pipe authorized under Permit No. 3878, 1962-River Farms Company of California). [Additional Reference(s): DWR Levee Logs, 1990] FS Date: 6/10/2014

View of landward side.

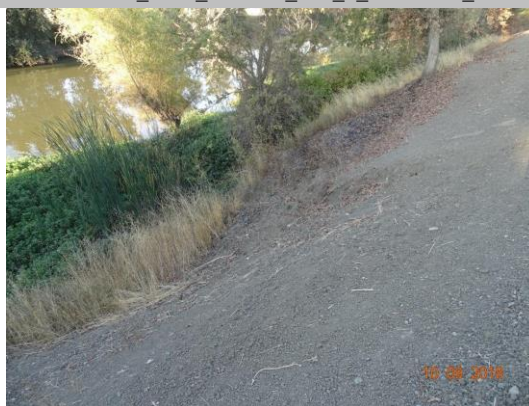
Photo 1 of 4 : SP_2019_RD0787_212_9_20190304_00004.jpg

LM Start	0.73	Rating **	A/W	Issue No.	9
LM End	0.73	Issue Type +	Ma	Location *	WS
Category	Earthen Levee			GPS Latitude/Longitude	
				Start	End
Item	Erosion / Bank Caving			38.795814 °	38.795814 °
				-121.736799 °	-121.736799 °
DWR ID	DWR_RD0787_01_s_2017_9				
Comment Code					
E1 : Note and monitor erosion site.					
Inspector Comment					
Erosion on the waterside slope from 2017 storms. Recommend monitoring.

View of erosion on the waterside slope, facing upstream. Fall 2018.

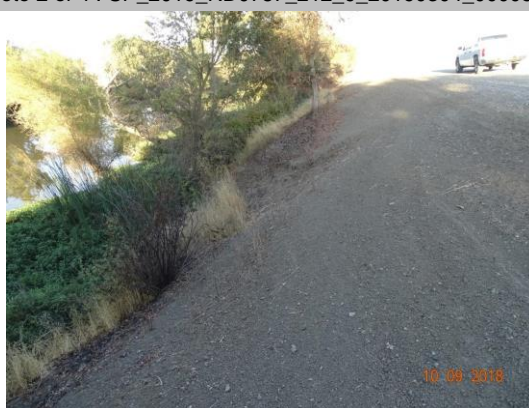
Photo 2 of 4 : SP_2019_RD0787_212_9_20190304_00005.jpg

Additional view of erosion, facing upstream. Fall 2018.

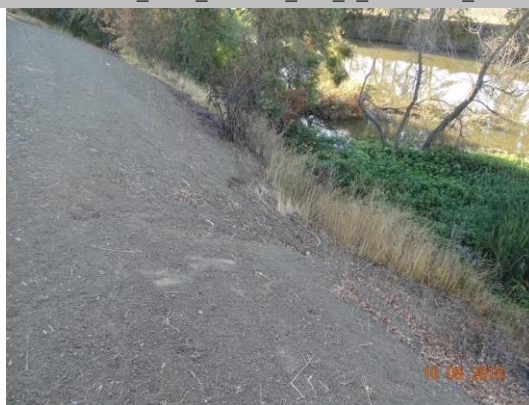
Photo 3 of 4 : SP_2019_RD0787_212_9_20190304_00006.jpg

View of erosion, facing downstream. Fall 2018.

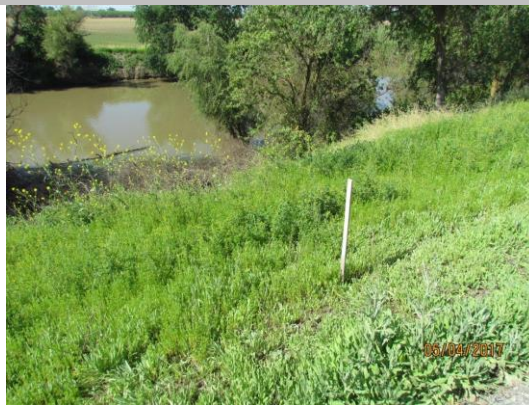
Photo 4 of 4 : SP_2019_RD0787_212_9_20190304_00007.jpg

LM Start	0.73	Rating **	A/W	Issue No.	9 (cont)	
LM End	0.73	Issue Type +	Ma	Location *	WS	
Category	Earthen Levee			GPS Latitude/Longitude		
				Start		End
Item	Erosion / Bank Caving			38.795814 °	38.795814 °	
				-121.736799 °	-121.736799 °	
DWR ID	DWR_RD0787_01_s_2017_9					
Comment Code						
E1 : Note and monitor erosion site.						
Inspector Comment						
Erosion on the waterside slope from 2017 storms. Recommend monitoring.

View of what appears to be a slope stability issue on waterside slope. Spring 2017.

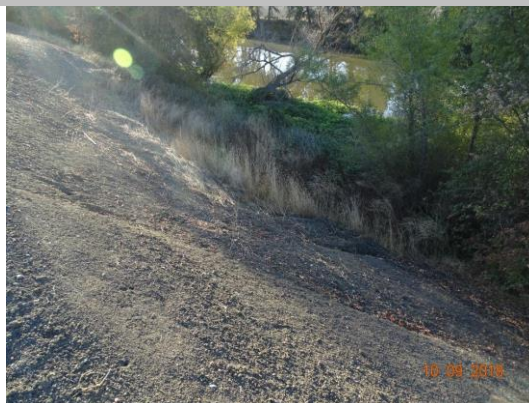
Photo 1 of 3 : SP_2019_RD0787_212_12_20190304_00008.jpg

LM Start	0.75	Rating **	A/W	Issue No.	12
LM End	0.75	Issue Type +	Ma	Location *	WS
Category	Earthen Levee			GPS Latitude/Longitude	
				Start	End
Item	Erosion / Bank Caving			38.795891 °	38.795891 °
				-121.737098 °	-121.737098 °
DWR ID	DWR_RD0787_01_f_2017_12				
Comment Code					
E1 : Note and monitor erosion site.					
Inspector Comment					
Erosion on the waterside slope from 2017 storms. Recommend monitoring.

View of erosion on the waterside slope, facing downstream. Fall 2018.

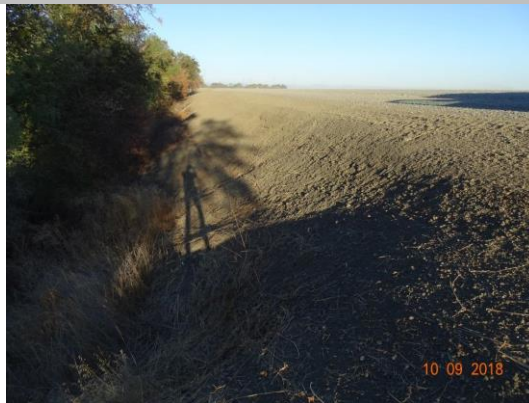
Photo 2 of 3 : SP_2019_RD0787_212_12_20190304_00009.jpg

View of the erosion the waterside slope, facing upstream. Fall 2018.

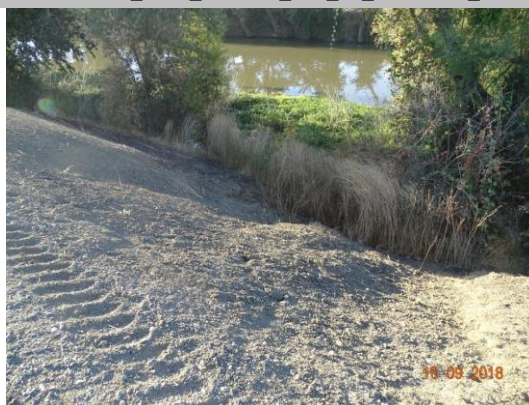
Photo 1 of 2 : SP_2019_RD0787_212_15_20190304_00011.jpg

LM Start	0.77	Rating **	A/W	Issue No.	15
LM End	0.77	Issue Type +	Ma	Location *	WS
Category	Earthen Levee			GPS Latitude/Longitude	
				Start	End
Item	Erosion / Bank Caving			38.795996 °	38.795996 °
				-121.737493 °	-121.737493 °
DWR ID	DWR_RD0787_01_f_2018_15				
Comment Code					
E1 : Note and monitor erosion site.					
Inspector Comment					
Erosion on the waterside slope from 2017 storms. Recommend monitoring.

View of erosion on the waterside slope, facing downstream. Fall 2018.

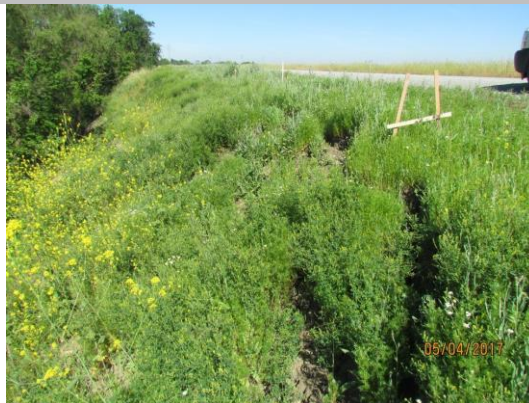
Photo 2 of 2 : SP_2019_RD0787_212_15_20190304_00012.jpg

View of sloughing on waterside slope. Spring 2017.

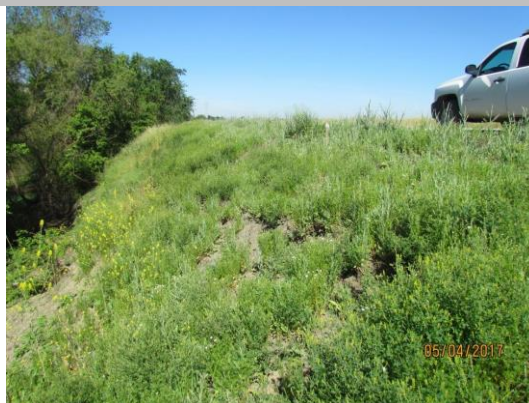
Photo 2 of 2 : SP_2019_RD0787_212_16_20190304_00014.jpg

LM Start	0.78	Rating **	A/W	Issue No.	16
LM End	0.78	Issue Type +	Ma	Location *	WS
Category	Earthen Levee			GPS Latitude/Longitude	
				Start	End
Item	Erosion / Bank Caving			38.796042 °	38.796042 °
				-121.737661 °	-121.737661 °
DWR ID	DWR_RD0787_01_s_2017_16				
Comment Code					
E1 : Note and monitor erosion site.					
Inspector Comment					
Erosion on the waterside slope from 2017 storms. Recommend monitoring.

View of what appears to be sloughing on the waterside slope. Spring 2017.
